AFRL-ML-TY-TR-2004-4531

Evaluation Of Elastomeric Polymers Used For External Reinforcement Of Masonry Walls Subjected To Blast.

A Thesis

Danica Leigh Thornburg

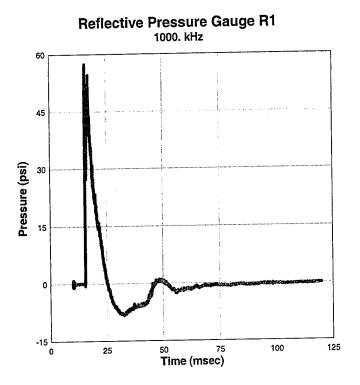
FIG. 18. Test 1, Gauge R1

The maximum pressures recorded by the pressure gauges were (R1) 57 psi at 15.5 msec, (R2) 52.5 psi at 16.7 msec, and (R3) 44 psi at 17.3 msec. The maximum pressures recorded by the pressure gauges were (F1) 27 psi at 15.4 msec and (F2) 0.7 psi at 50 msec. The maximum deflections recorded by the laser gauges were (L1) 7.3 in. at 49 msec and (L2) 7.3 in. at 1.0 msec.

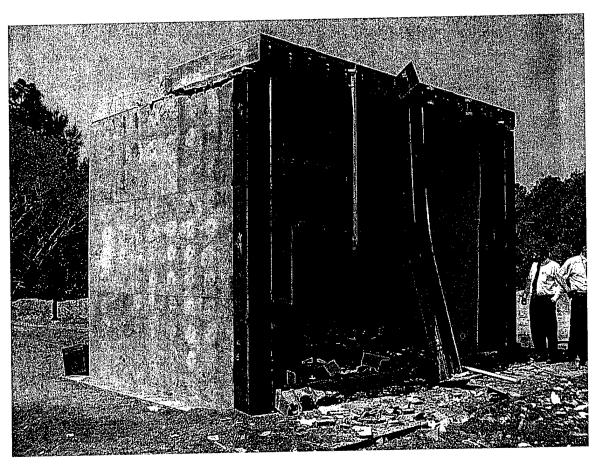
FIG. 56. Test 2, Post-Test Structure

Both the control wall and retrofit wall panels collapsed in this test. Mortar layers at mid-height of the wall experienced the highest stresses and failed in tension. The steel beam separating the walls was bent. In addition to the walls being destroyed, there was damage to the reaction structure.

Fig. 56 shows the post-test reaction structure. The damage to the reaction structure is evident. Fig. 57 shows a side view of the reaction structure. Fig. 58 shows the debris of the control wall, while Fig. 59 shows the debris of the retrofitted wall.

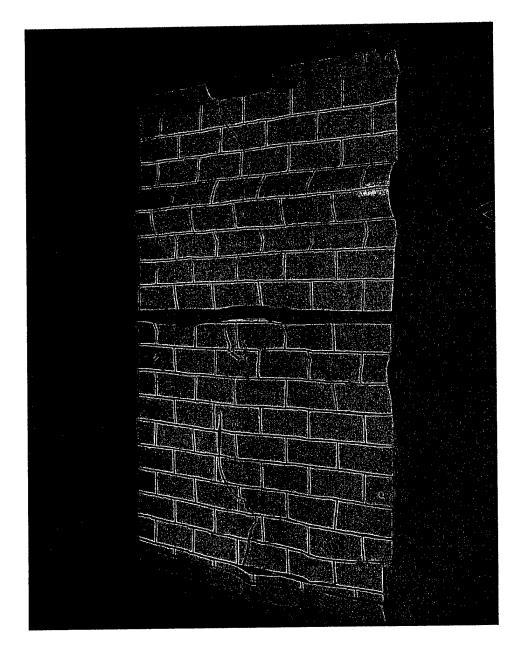
Fig. 61 shows the piece of retrofit material after debris was removed. This image shows where the retrofit failed.

FIG. 61. Test 2, Post-Test Retrofit Material

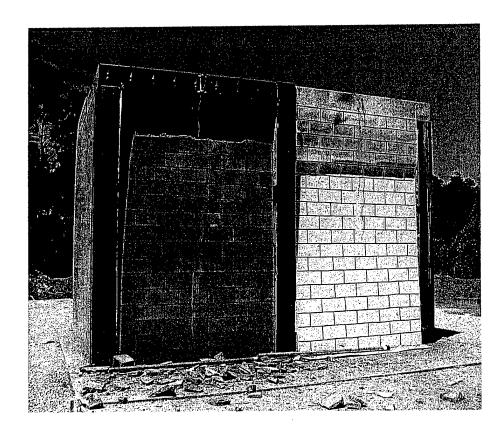
FIG. 83. Test 3, Walls A and B, Damage

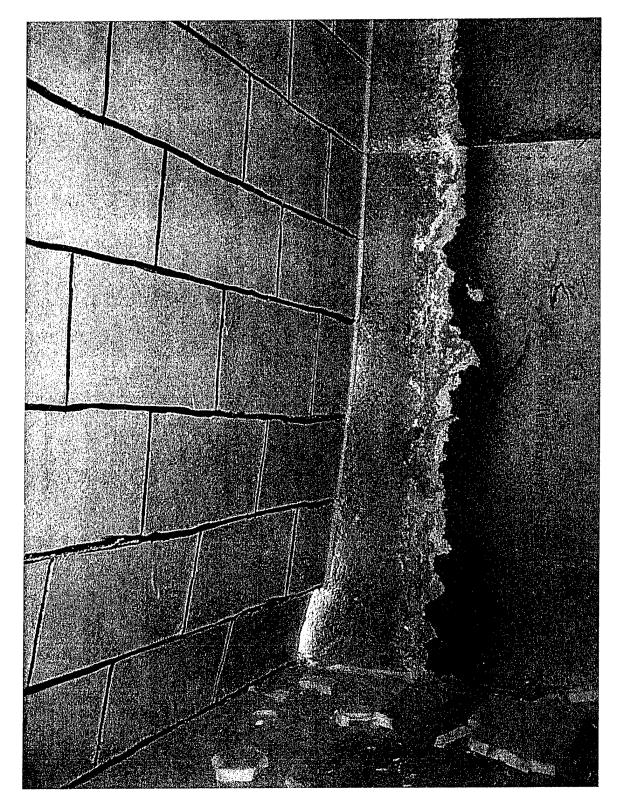
FIG. 85. Test 3, Wall A, Left Bottom Interior

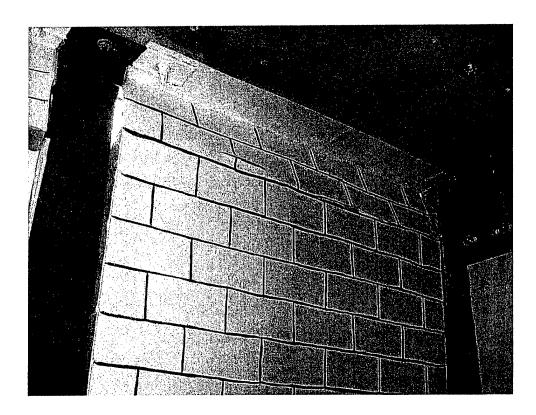
FIG. 86. Test 3, Wall A, Left Top Interior

Wall B had less damage than the singly retrofitted wall. Both were successful in preventing flying debris. Wall A had a polymer tear on the inside due to high shear at a mortar joint.

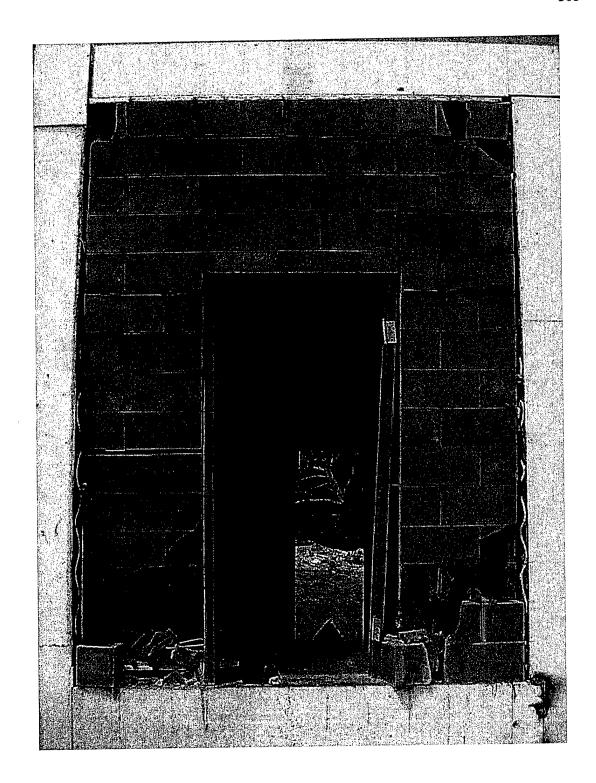
FIG. 114. Test 9, Posttest Door

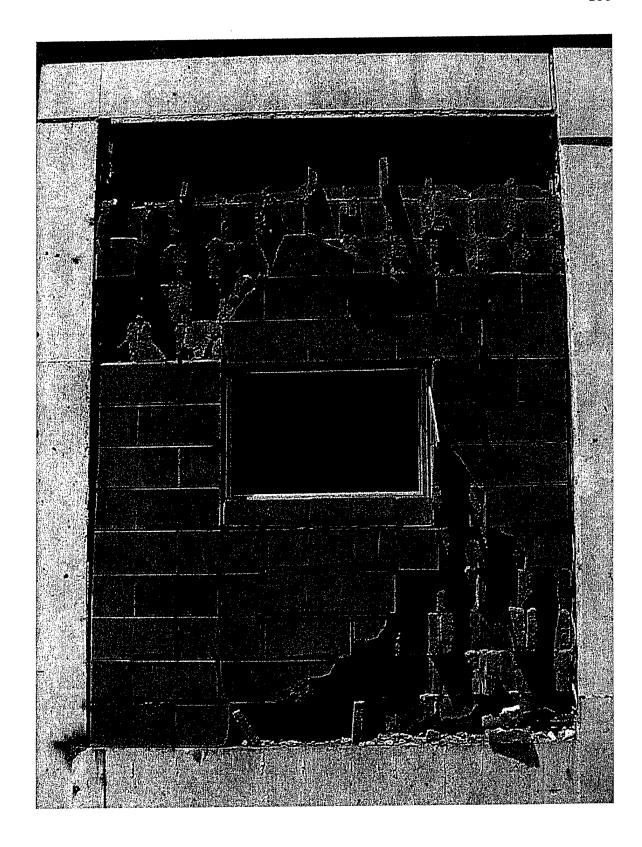
FIG. 115. Test 9, Posttest Window

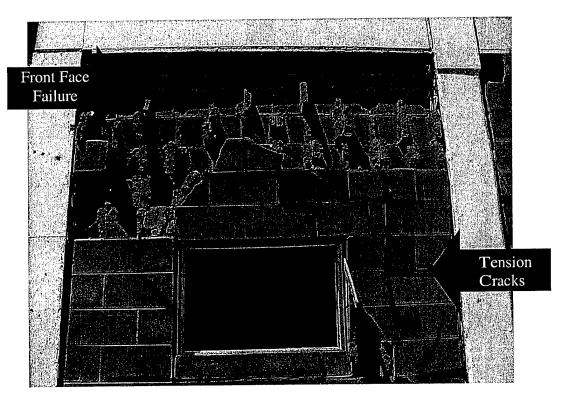
The front face and mortar failures occur in the first few milliseconds after the blast is detonated. Close-up images of mortar and front face failures are shown in Figs. 116 through 118. Also shown in these images are large cracks, resulting from tension in the walls caused by flexure.

FIG. 116. Test 9, Top Left Wall Defacing

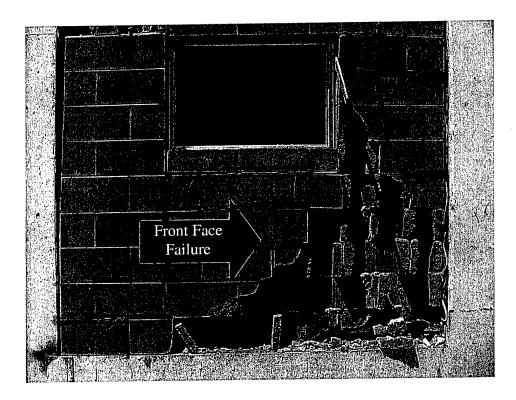
FIG. 117. Test 9, Bottom Left Wall Defacing

The mortar bond between the blocks is weak in tension. When the blast load reaches the structure, the shock wave fractures some of the front faces of the blocks and breaks some of the mortar bonds. The wall then flexes inward causing high shear in the upper and lower mortar joints followed by tension failure at the inside center of the wall. The negative phase of the blast loading then pulls the wall back outward. During these movements, mortar joints in the walls fail. This causes cracking throughout the lateral mortar joints.

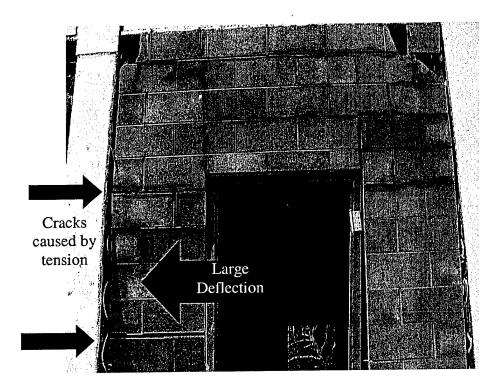
FIG. 118. Test 9, Right Wall Cracks

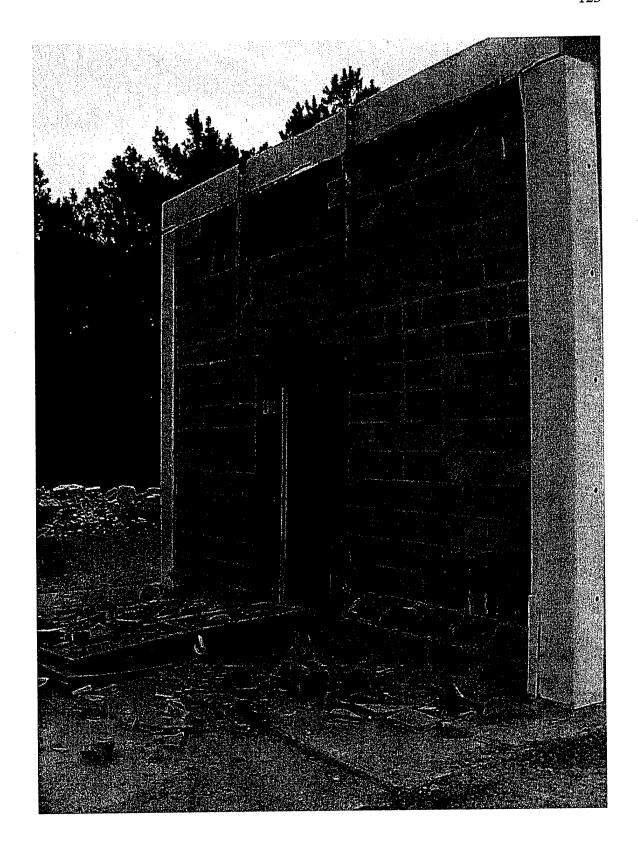
FIG. 134. Test 10, Posttest Test Structure

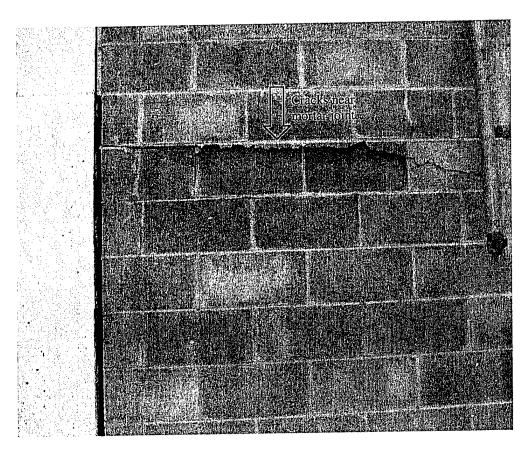
FIG. 135. Test 10, Shear Cracks, Left Side

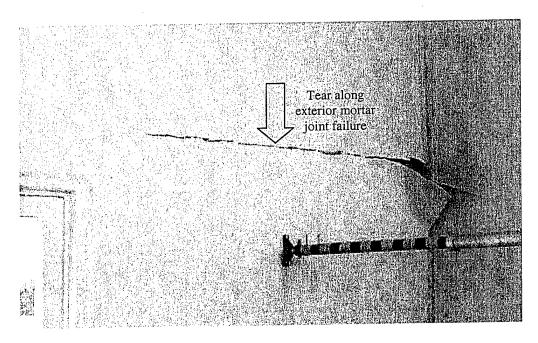
FIG. 136. Test 10, Left Side Interior Tear

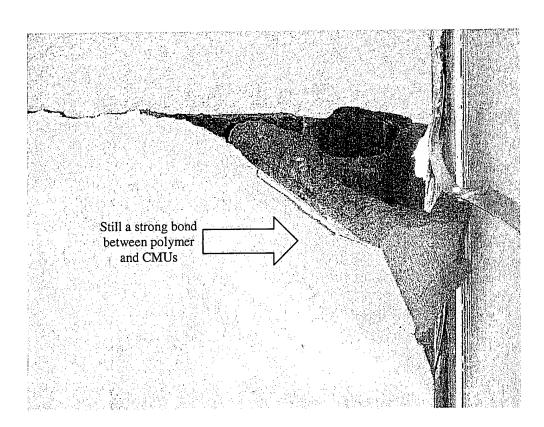
FIG. 137. Test 10, Protruded Block, Left Side

The polymer coating on the interior of the wall experienced a tear due to shear from mortar joint failure. A tear easily propagates once initiated. Mortar joint failure and consequent tears in the polymer are shown in Figs. 135 through 139. The steel door is shown in Fig. 140.

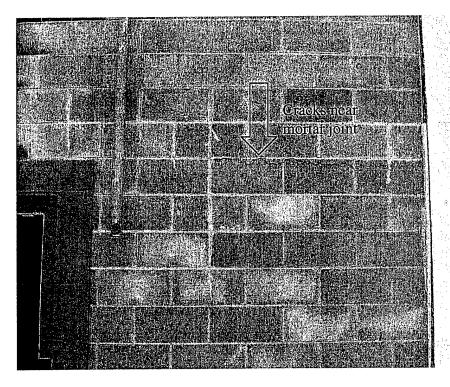
FIG. 138. Test 10, Shear Cracks, Right Side

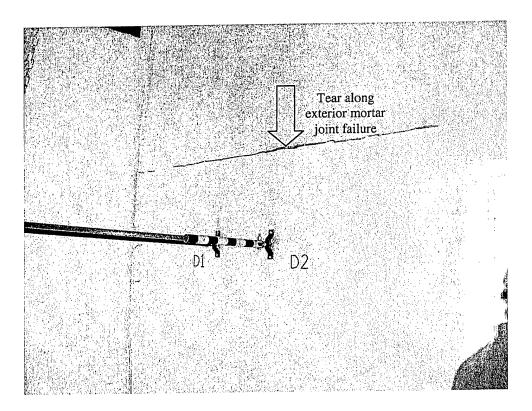
FIG. 139. Test 10, Right Side Interior Tear

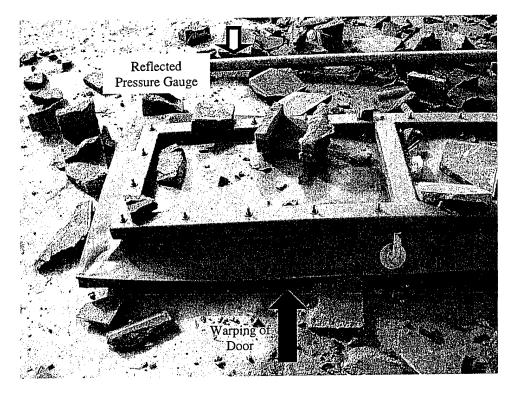
FIG. 140. Test 10, Steel Door, Post Test

The wall with the door sustained damage. There was defacing at the top and bottom of the wall. The door connections failed. There were mortar bond cracks at

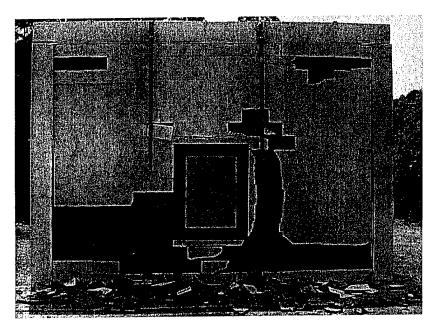
FIG. 175. Test 11, Test Structure, Post-Test

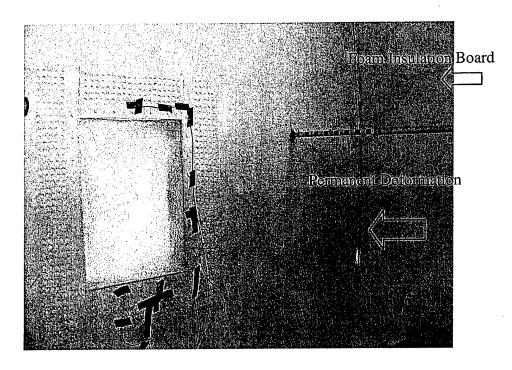
FIG. 178. Test 11, Left Side Deflection

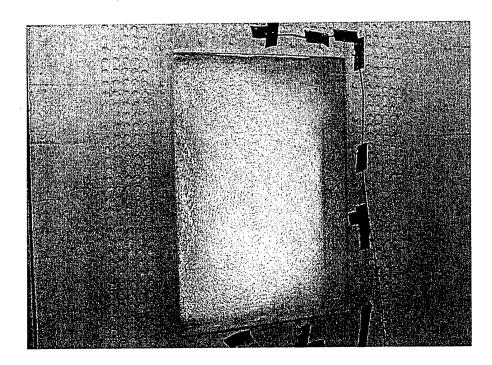
The window glass was shattered in the test, but the film that was applied kept it intact. Reflected pressure gauges were placed inside the double windowpanes. Reflected pressure outside the window averaged 37 psi. Pressure just inside the window, however, averaged only 9 psi. This reduction was due to the windowpane and the air gaps that were placed there to dissipate pressure. The inside image of the window is shown in Fig. 179.

FIG. 179. Test 11, Post-Test Window

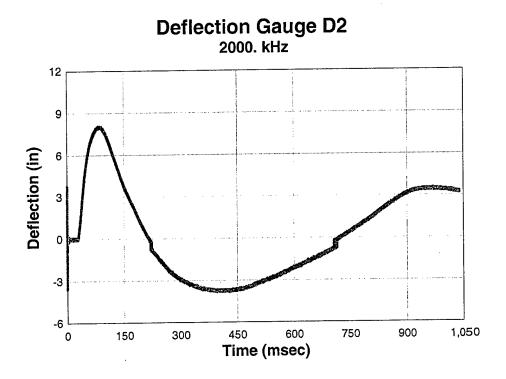
FIG. 198. Test 12, Gauge D2

The maximum pressures recorded by pressure gauges R1, R2, and R3 were (R1) 40.5 psi at 27.0 msec, (R2) 40.0 psi at 26.3 msec, and (R3) 41.6 psi at 27.0 msec. The maximum free-field pressure detected was (F1) 17.8 psi at 26.7 msec. The maximum deflection measured was (D2) 8.1 in. at 85.5 msec. The left wall failed, so deflection gauge D1 could not record a maximum deflection.

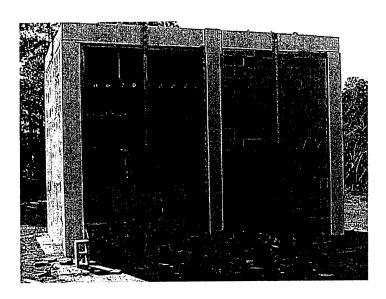
The result of Test 12 is shown in Fig. 199. The left wall collapsed fully. The polymer reinforcement failed at the top connection due to high shear stress. Since the blocks were not mortared together, there were no sections that remained intact, as there had been in other walls. Debris filled the left side of the test structure. A close-up image of the collapsed left wall is shown in Fig. 200.

FIG. 199. Test 12, Posttest Structure

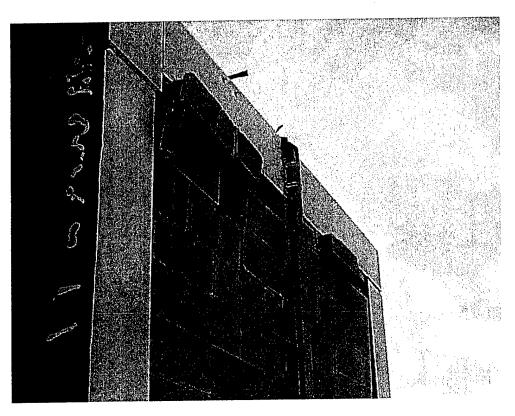
The lack of mortar on the walls did not prevent the polymer retrofit from being effective. Deflection data from D2 shows that the wall deflected inward approximately 8 in. and then outward about 4 in. Even deflecting outward, the polymer held the wall together. Some of the top row blocks sheared out. Furthermore, there appeared to be great arching forces due to the lack of mortar. Gravity collapse is predicted when the deflection of the wall equals the thickness of the wall and the right wall deflected more than its thickness. With the application of the polymer, however, the wall can deflect more without collapse. Images of the right wall are shown in Figs. 201 through 205.

FIG. 201. Test 12, Right Wall, Top

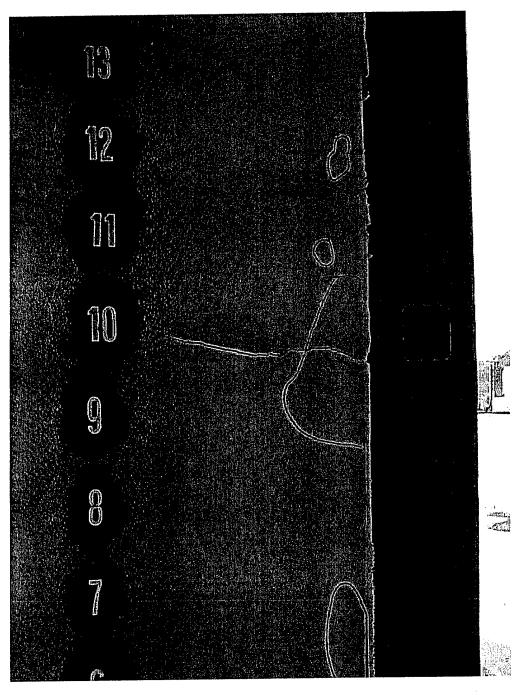
204 shows a tear in the polymer on the other side of the right wall. The tears on the left and right sides were in the same course of the blocks. The tears, however, were not connected. This was a direct result of the deflection mid-height of the structure.

FIG. 203. Test 12, Right Wall, Bubbles and Right Tear

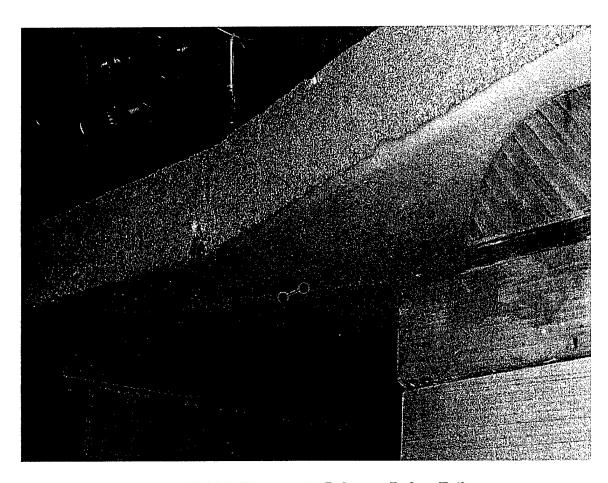
FIG. 216. Elastomeric Polymer, Before Failure

Before any tears were observed in the elastomeric polymer, the 0.06-in. gap had widened to 0.79 in. Fig. 216 shows the maximum stretch the elastomeric polymer successfully withstood before tearing.

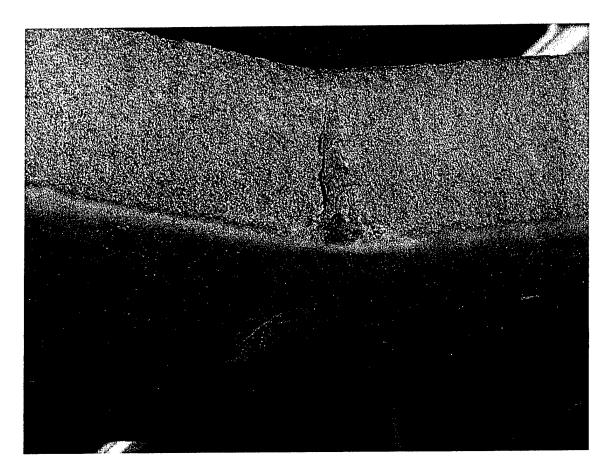
At approximately 900 lb, the elastomeric polymer started to tear. However, the polymer was still resisting load. When the applied load reached 1100 lb, the deflectometer was removed in anticipation of the collapse of the block onto the data collection equipment. The block collapsed at a load of 1160 lb. Fig. 217 shows the tear in the polymer as well as the size of the crack in the concrete.

FIG. 217. Elastomeric Polymer after Tearing

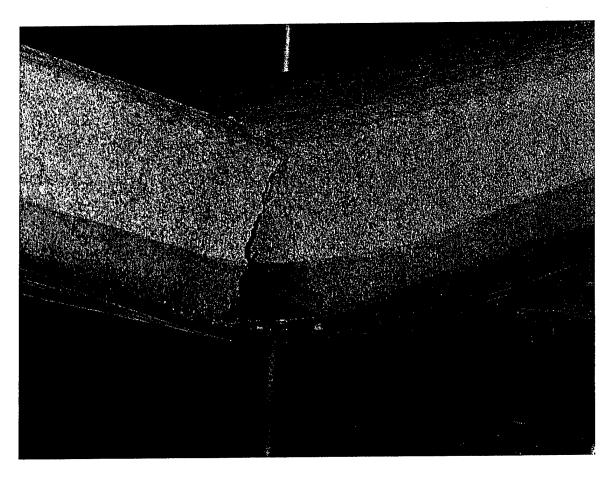
FIG. 218. Polyester Thermoplastic Polyurethane

The polyester thermoplastic polyurethane was placed in the testing machine in the same manner as the black polypropylene/polypropylene woven material. The block was loaded. Deflection was recorded at 100-lb increments. After 400 lb, the polyurethane lost bond with the block and took no additional load. However, the material kept the block from collapsing, allowing it to deflect to 0.35 in. An image of the block and the polyester thermoplastic polyurethane can be seen in Fig. 218.

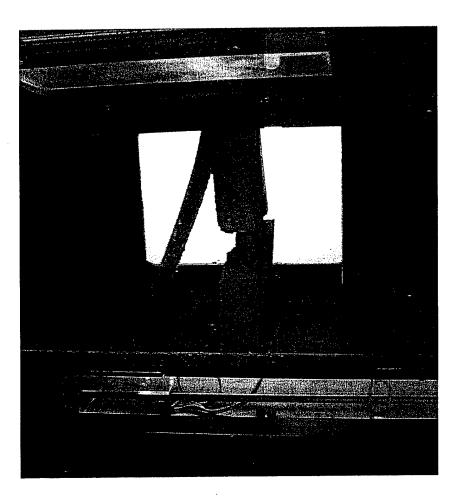
FIG. 259. Gas Gun Test 2, Sample 1 Side View

A 6061 T6 aluminum cylinder weighing 0.35 lb was selected to impact the polymer-coated pavers. For Sample 1, the pressure of 90.6 used to launch the projectile was too high and the concrete fragmented. The polymer on the back separated from the concrete. The interface between the polymer and the block absorbed most of the energy involved in the impact. This indicates that the polymer did not fail, but the concrete failed in tension. Even with the failure, the membrane was successful in stopping the projectile, as the projectile was found on the right side of the block. The side view of Sample 1 is shown in Fig. 259. It is shown in Fig. 260 after being removed from the Gas Gun.
